Alternatives to Turbo Roundabouts

Mark Lenters, P.E., Kimley-Horn and Associates, Inc.

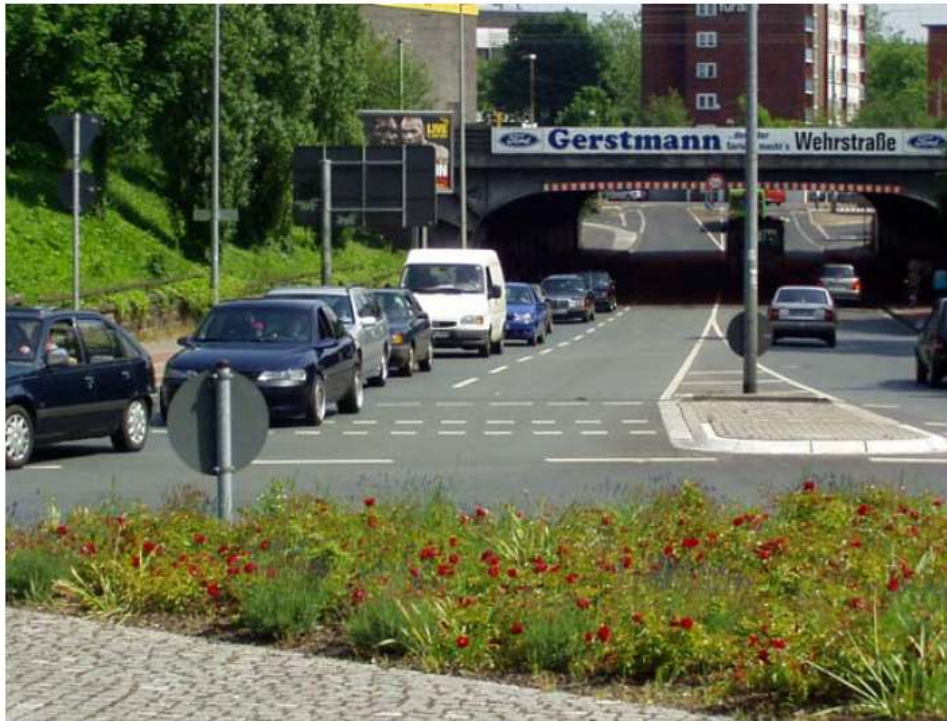
Fig. 9: *Typical driver behavior at a compact two-lane roundabout: unused left lane on a two-lane entry*

- Due to interactions of circulating flows with fast vehicles leaving the circle from the inner lane, these two-lane exits often are a reason for injury accidents.
- Therefore, multilane roundabouts are not recommended for application in Germany. Especially 2-lane exits are completely banned.

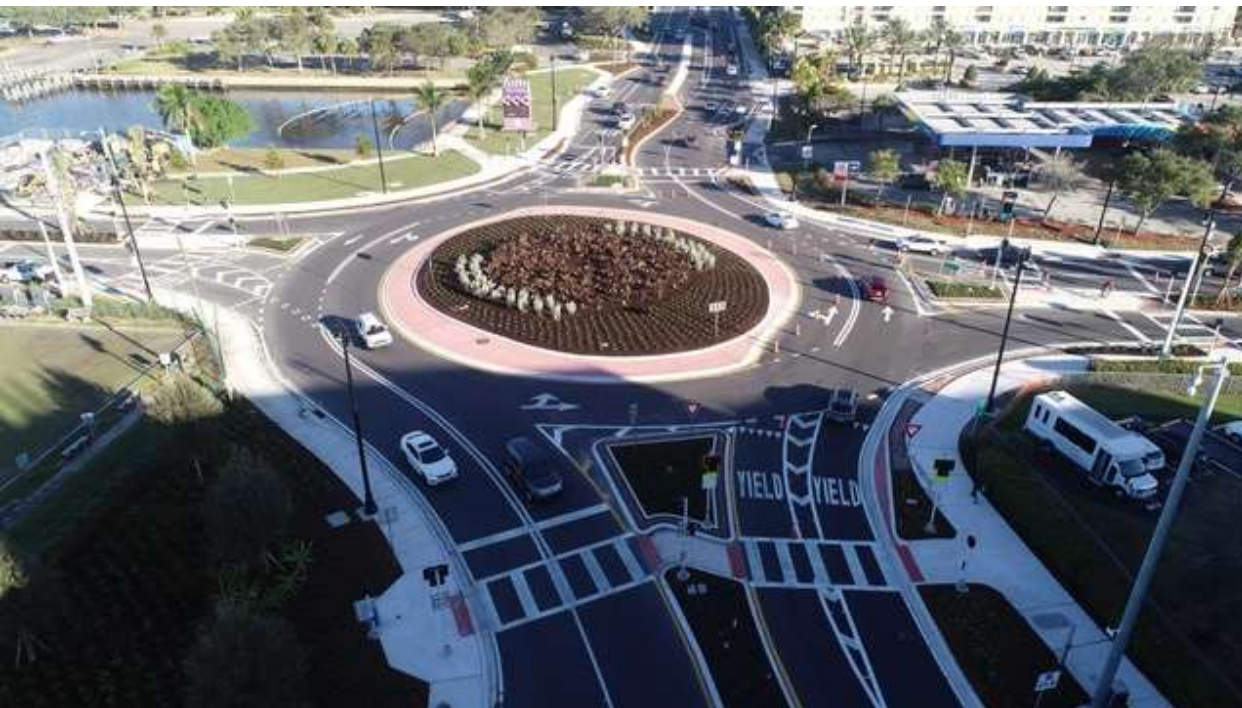
**Alternative to
Turbo Concept,
Alpharetta, GA**

No raised dividers

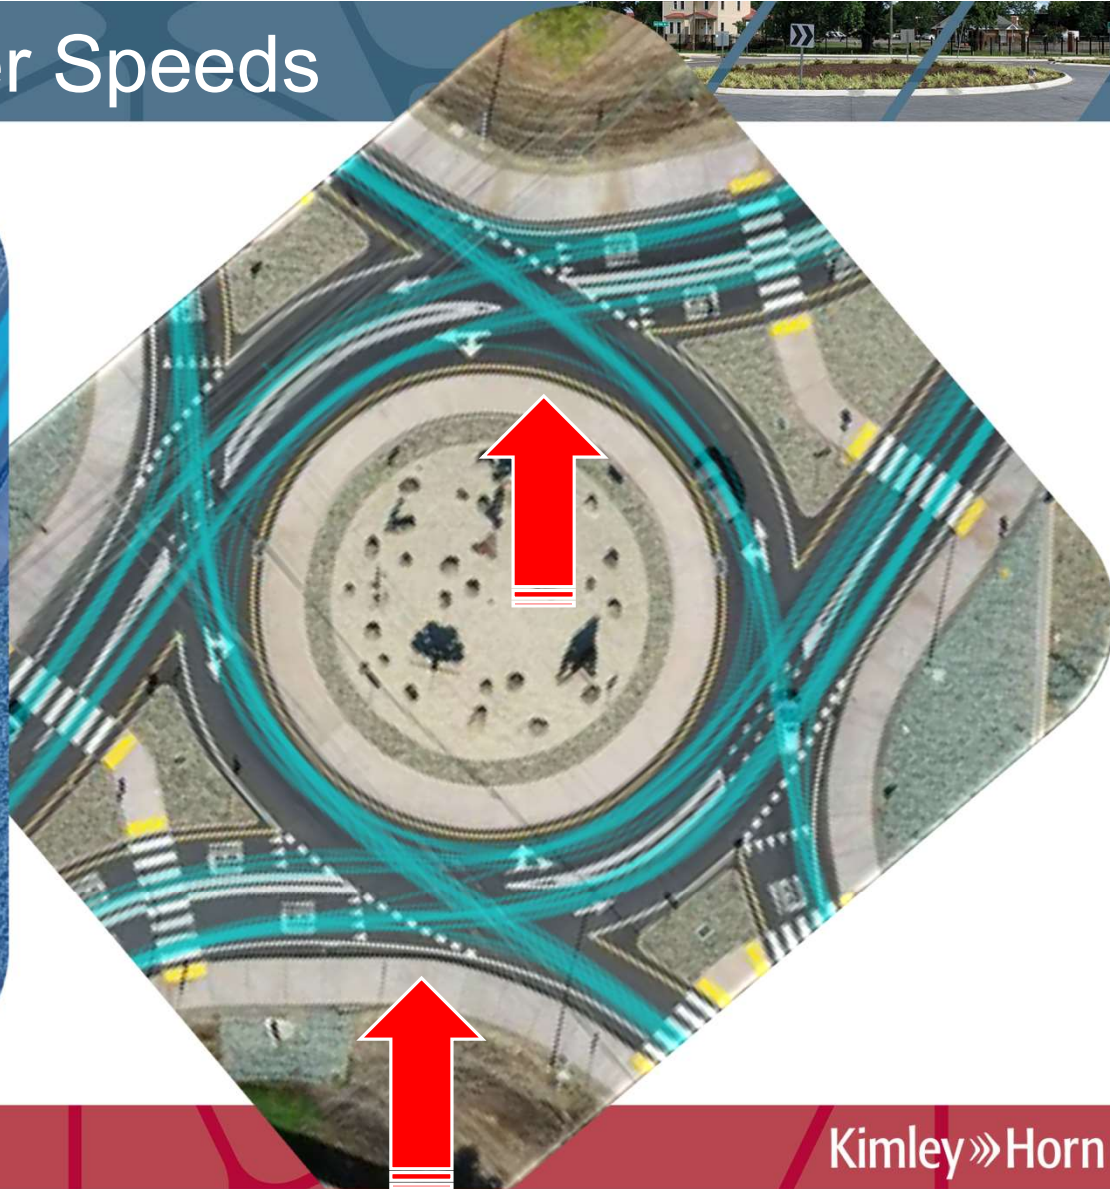
Lane Discipline and Lower Speeds
